## Project 17 2023 Inspection

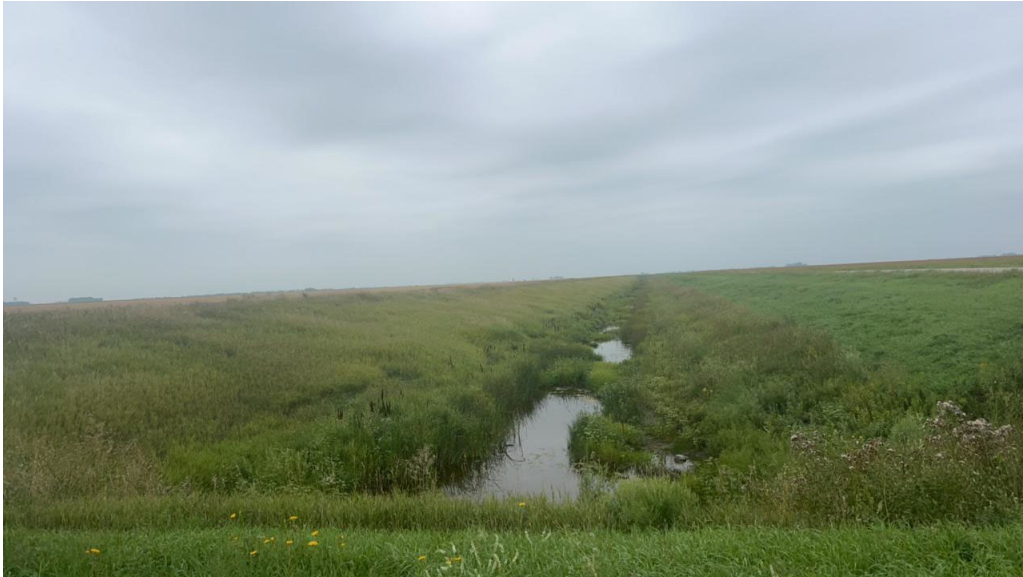
<b>Township:</b>	<b>148</b>	<b>Range:</b>	<b>26</b>	<b>Section:</b>	<b>47</b>
<b>Municipality/Township Name:</b>	<b>Hammond</b>				
<b>Date Inspected:</b>	<b>08/22/2023</b>				
<b>Inspection Item:</b>	<b>Drainage Way</b>				
<b>Needs Repair:</b>	<b>No</b>				
<b>Continue to Monitor:</b>	<b>No</b>				
<b>Repair Completed:</b>					
<b>Notes:</b>	<b>Plugging</b>

**Looking west**

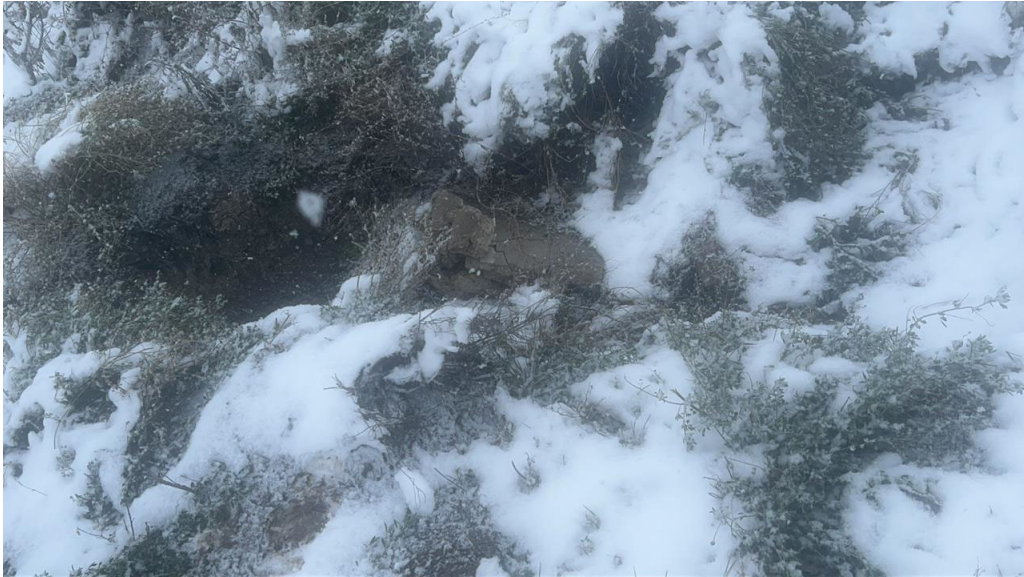
<b>Township:</b>	<b>148</b>	<b>Range:</b>	<b>28</b>	<b>Section:</b>	<b>47</b>
<b>Municipality/Township Name:</b>	<b>Hammond</b>				
<b>Date Inspected:</b>	<b>10/30/2023</b>				
<b>Inspection Item:</b>	<b>Culvert</b>				
<b>Needs Repair:</b>	<b>Yes</b>				
<b>Continue to Monitor:</b>	<b>Yes</b>				
<b>Repair Completed:</b>	<b>No</b>				
<b>Notes:</b>	<b>Wash out. this is an area we repaired prior and it did it's job by not taking out the road, but there is still a small washout in the north/south ditch</b>

**Wash out**

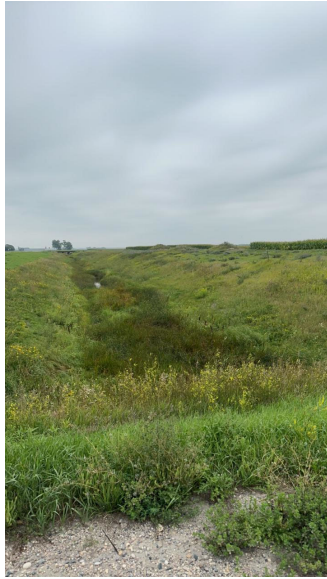
**Attachment**

<b>Township:</b>	<b>148</b>	<b>Range:</b>	<b>29</b>	<b>Section:</b>	<b>46</b>
<b>Municipality/Township Name:</b>	Russia				
<b>Date Inspected:</b>	08/22/2023				
<b>Inspection Item:</b>	Other				
<b>Needs Repair:</b>	No				
<b>Continue to Monitor:</b>	Yes				
<b>Repair Completed:</b>	No				
<b>Notes:</b>	Sediment piles to east need to be removed. Spoke with Elliot, Decided to wait it out and see if we can use that fill for other damaged areas.

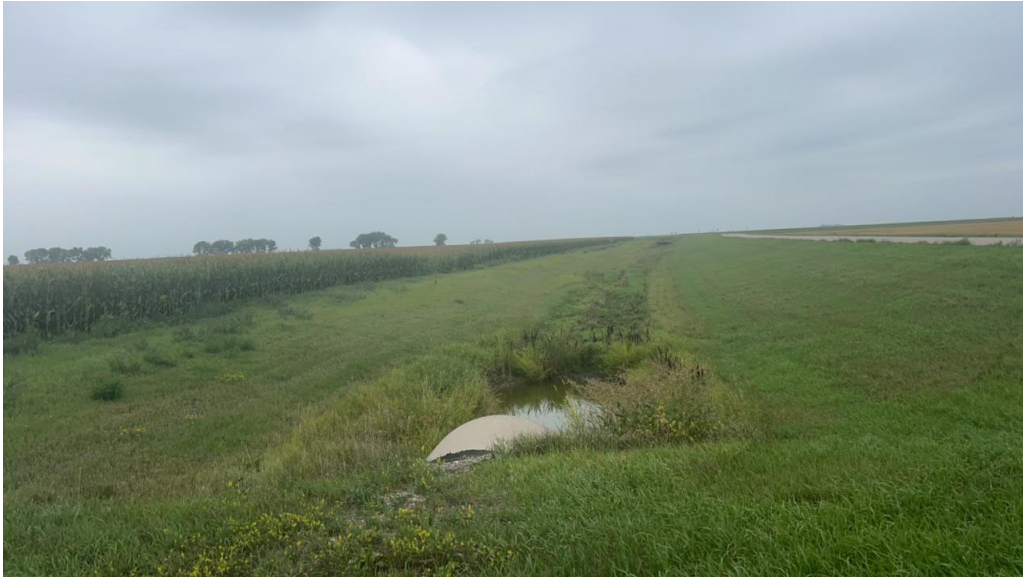
**Attachment**

<b>Township:</b>	<b>148</b>	<b>Range:</b>	<b>25</b>	<b>Section:</b>	<b>47</b>
<b>Municipality/Township Name:</b>	<b>Hammond</b>				
<b>Date Inspected:</b>	<b>08/22/2023</b>				
<b>Inspection Item:</b>	<b>Drainage Way</b>				
<b>Needs Repair:</b>	<b>No</b>				
<b>Continue to Monitor:</b>	<b>Yes</b>				
<b>Repair Completed:</b>					
<b>Notes:</b>	<b>Looks like water standing at culvert</b>

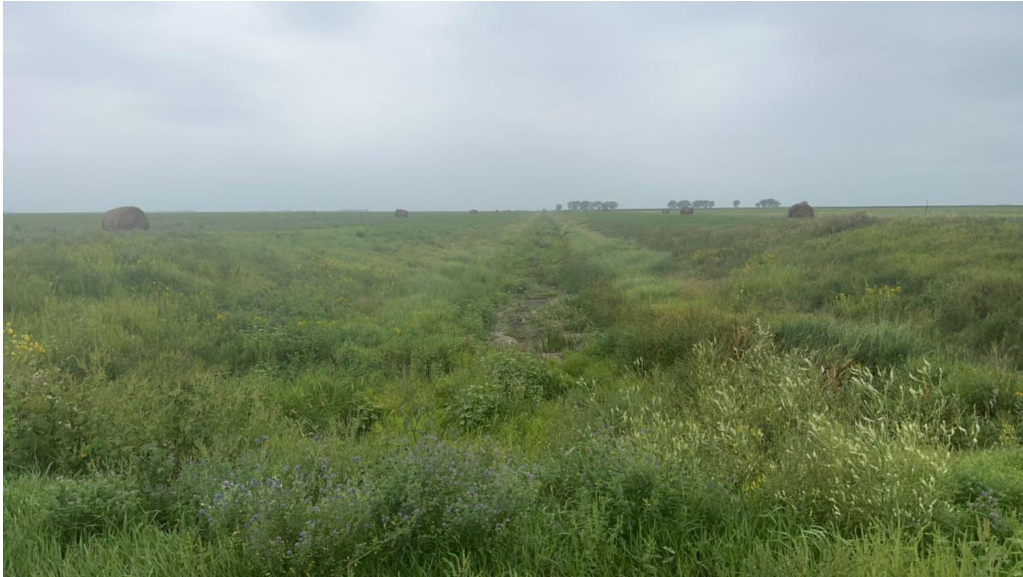
<b>Township:</b>	<b>148</b>	<b>Range:</b>	<b>29</b>	<b>Section:</b>	<b>46</b>
<b>Municipality/Township Name:</b>	Russia				
<b>Date Inspected:</b>	08/22/2023				
<b>Inspection Item:</b>	Drainage Way				
<b>Needs Repair:</b>	No				
<b>Continue to Monitor:</b>	No				
<b>Repair Completed:</b>					
<b>Notes:</b>	Fair condition Buffer good

Looking west

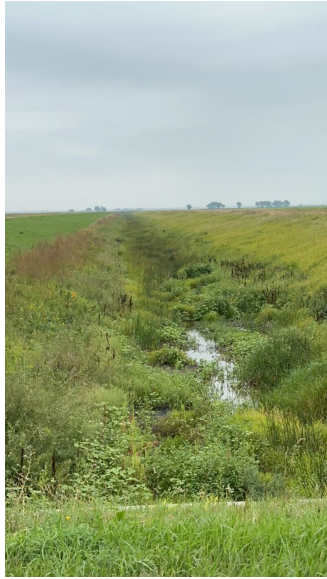
**Attachment**

<b>Township:</b>	<b>148</b>	<b>Range:</b>	<b>26</b>	<b>Section:</b>	<b>47</b>
<b>Municipality/Township Name:</b>	<b>Hammond</b>				
<b>Date Inspected:</b>	<b>08/22/2023</b>				
<b>Inspection Item:</b>	<b>Drainage Way</b>				
<b>Needs Repair:</b>	<b>No</b>				
<b>Continue to Monitor:</b>	<b>No</b>				
<b>Repair Completed:</b>					
<b>Notes:</b>	<b>East ponded water</b>

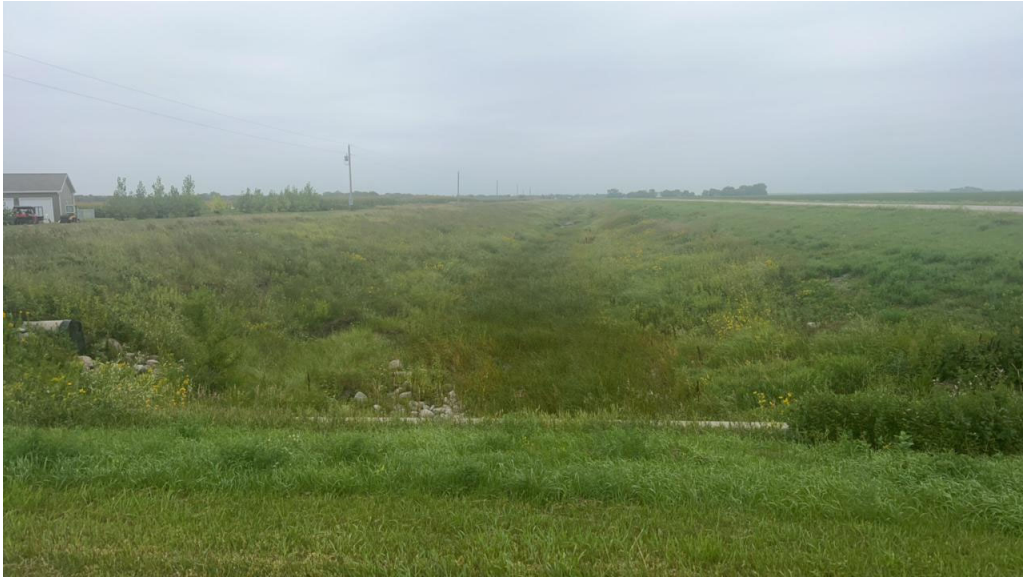
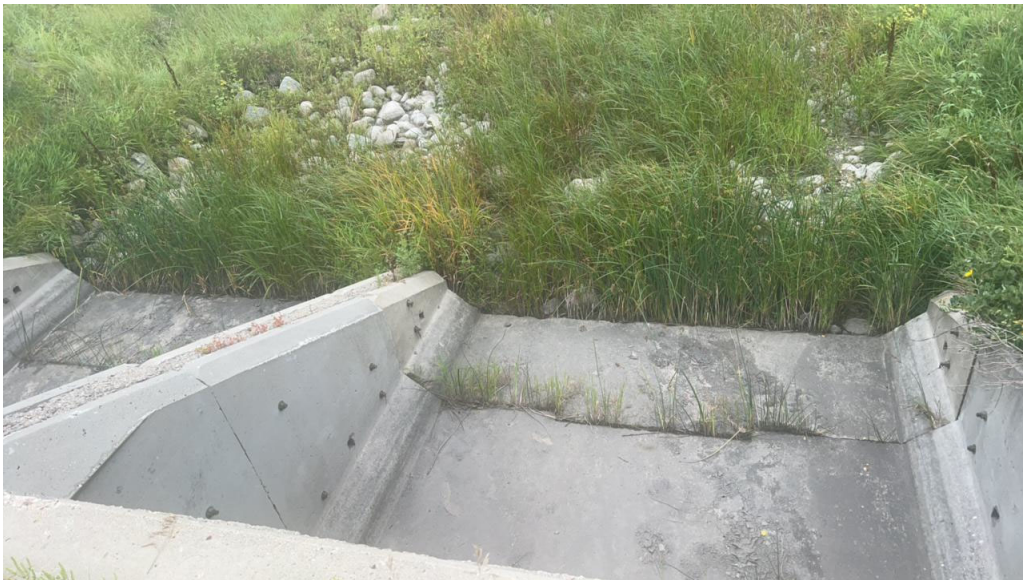
<b>Township:</b>	<b>148</b>	<b>Range:</b>	<b>28</b>	<b>Section:</b>	<b>48</b>
<b>Municipality/Township Name:</b>	<b>Vineland</b>				
<b>Date Inspected:</b>	<b>08/22/2023</b>				
<b>Inspection Item:</b>	<b>Drainage Way</b>				
<b>Needs Repair:</b>	<b>No</b>				
<b>Continue to Monitor:</b>	<b>Yes</b>				
<b>Repair Completed:</b>					
<b>Notes:</b>	<b>Cleaning needed Ditch is dry but know from previous years water usually stands</b>

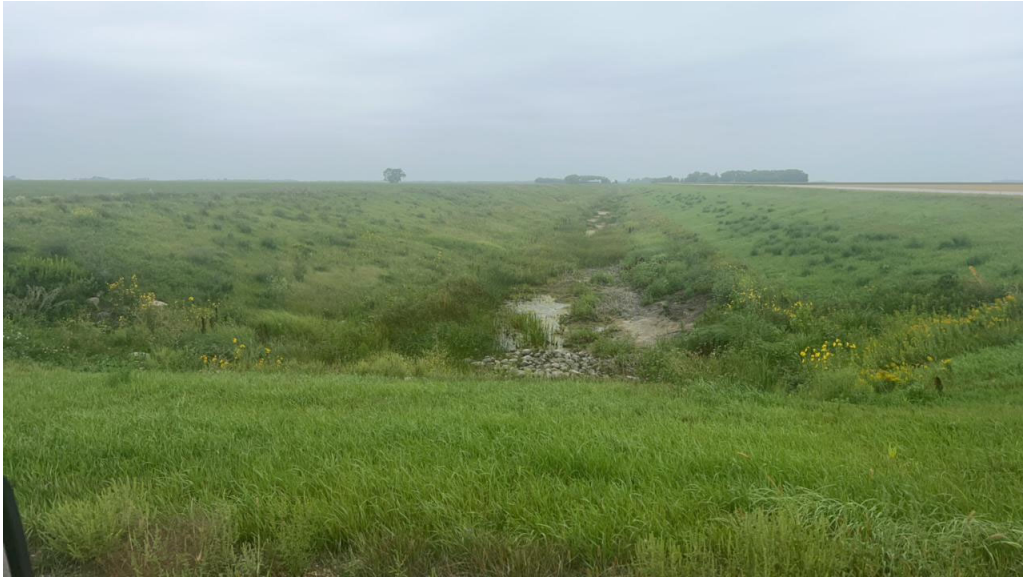
<b>Township:</b>	<b>148</b>	<b>Range:</b>	<b>25</b>	<b>Section:</b>	<b>48</b>
<b>Municipality/Township Name:</b>	Vineland				
<b>Date Inspected:</b>	08/22/2023				
<b>Inspection Item:</b>	Drainage Way				
<b>Needs Repair:</b>	No				
<b>Continue to Monitor:</b>	Yes				
<b>Repair Completed:</b>					
<b>Notes:</b>	Water pooling is spots. Needs cleaning

**Looking west**

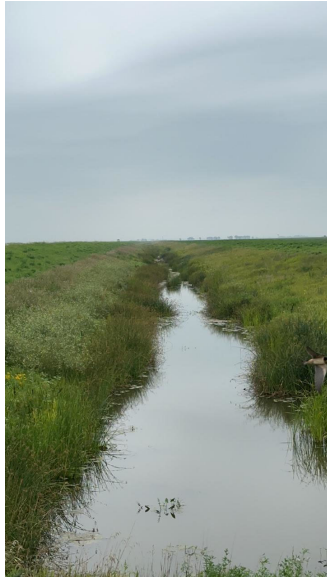
**Attachment**

<b>Township:</b>	<b>148</b>	<b>Range:</b>	<b>28</b>	<b>Section:</b>	<b>47</b>
<b>Municipality/Township Name:</b>	<b>Hammond</b>				
<b>Date Inspected:</b>	<b>08/22/2023</b>				
<b>Inspection Item:</b>	<b>Drainage Way</b>				
<b>Needs Repair:</b>	<b>No</b>				
<b>Continue to Monitor:</b>	<b>No</b>				
<b>Repair Completed:</b>					
<b>Notes:</b>	<b>East ponded water</b>

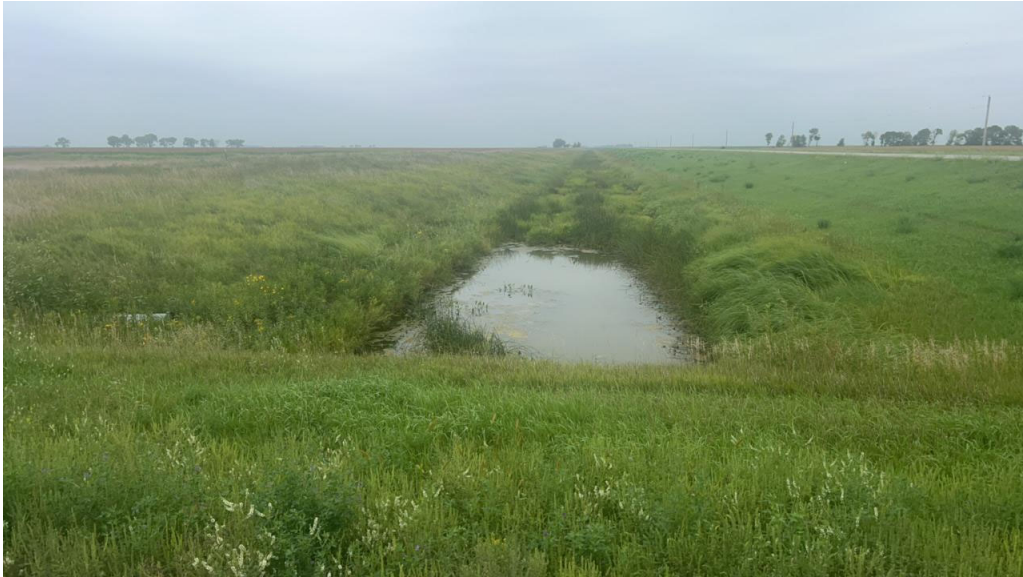
**Attachment**

<b>Township:</b>	<b>148</b>	<b>Range:</b>	<b>28</b>	<b>Section:</b>	<b>47</b>
<b>Municipality/Township Name:</b>	<b>Hammond</b>				
<b>Date Inspected:</b>	<b>08/22/2023</b>				
<b>Inspection Item:</b>	<b>Drainage Way</b>				
<b>Needs Repair:</b>	<b>Yes</b>				
<b>Continue to Monitor:</b>	<b>No</b>				
<b>Repair Completed:</b>	<b>No</b>				
<b>Notes:</b>	<b>Definite plugging. Will have to propose a master plan with board of managers for a process for cleaning (phased or all at once)</b>

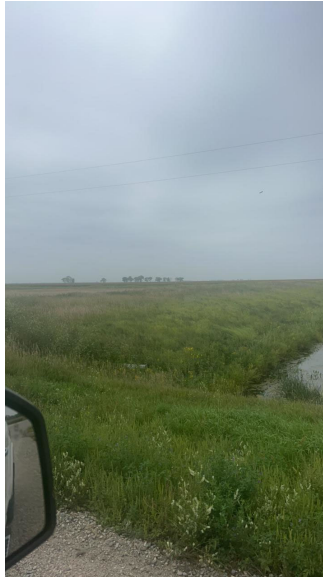
**Buffer good looking west**

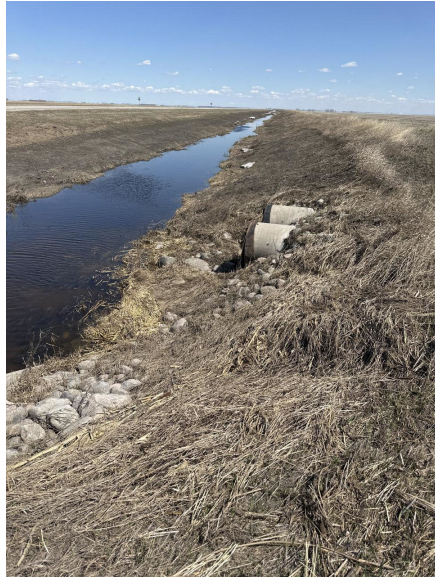
**Photo 1.jpg**

<b>Township:</b>	<b>148</b>	<b>Range:</b>	<b>27</b>	<b>Section:</b>	<b>47</b>
<b>Municipality/Township Name:</b>	<b>Hammond</b>				
<b>Date Inspected:</b>	<b>05/04/2023</b>				
<b>Inspection Item:</b>					
<b>Needs Repair:</b>					
<b>Continue to Monitor:</b>					
<b>Repair Completed:</b>					
<b>Notes:</b>	<b>Project 17 side inlets with flap</b>
