## Project 17 2023 Inspection

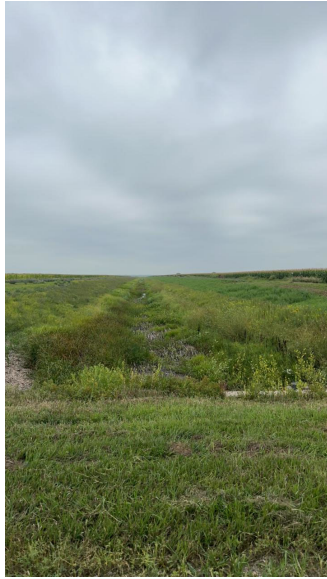
<b>Township:</b>	<b>148</b>	<b>Range:</b>	<b>29</b>	<b>Section:</b>	<b>46</b>
<b>Municipality/Township Name:</b>	Russia				
<b>Date Inspected:</b>	08/22/2023				
<b>Inspection Item:</b>	Drainage Way				
<b>Needs Repair:</b>	No				
<b>Continue to Monitor:</b>	No				
<b>Repair Completed:</b>					
<b>Notes:</b>	East

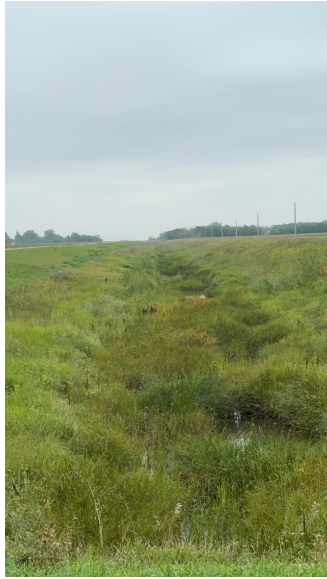
<b>Township:</b>	<b>148</b>	<b>Range:</b>	<b>27</b>	<b>Section:</b>	<b>48</b>
<b>Municipality/Township Name:</b>	Vineland				
<b>Date Inspected:</b>	08/22/2023				
<b>Inspection Item:</b>	Drainage Way				
<b>Needs Repair:</b>	No				
<b>Continue to Monitor:</b>	No				
<b>Repair Completed:</b>					
<b>Notes:</b>	Looking east

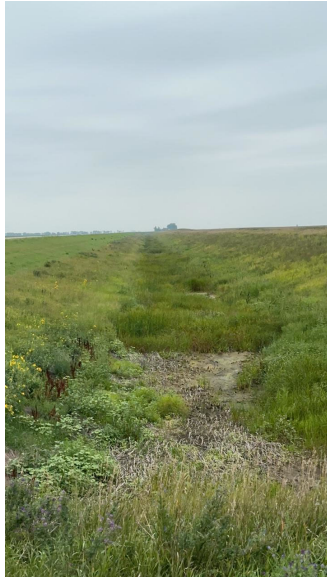
<b>Township:</b>	<b>148</b>	<b>Range:</b>	<b>25</b>	<b>Section:</b>	<b>48</b>
<b>Municipality/Township Name:</b>	<b>Vineland</b>				
<b>Date Inspected:</b>	<b>08/22/2023</b>				
<b>Inspection Item:</b>	<b>Drainage Way</b>				
<b>Needs Repair:</b>	<b>No</b>				
<b>Continue to Monitor:</b>	<b>No</b>				
<b>Repair Completed:</b>					
<b>Notes:</b>	<b>East</b>
